Lakeside Lake Sedimentation Study

August 12, 2008

Lakeside Sediment Survey

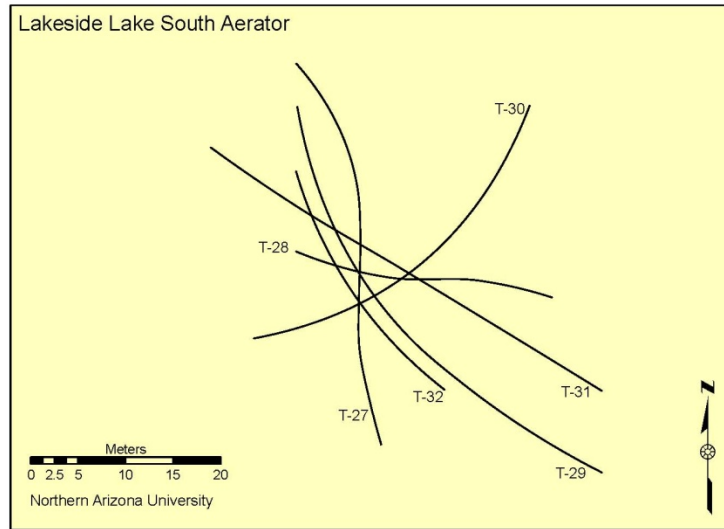
Figure 5. Seismic tracks (top) and seismic profiles (bottom) in vicinity of south aerator.

The deep aerators in the north and south basins appear to affect, and be affected by, sedimentation processes. Figures 4 and 5 show seismic profiles in the vicinity of the aerators. For both aerators, the transects along one axis show the aerator vent to be at the bottom of a trough, while transects along a perpendicular axis show the aerator vent to be at the crest of a mound about 20 meters in diameter. This geometry can be caused by sediments focusing toward the central part of each basin, becoming re-suspended by the aerators, and then settling around the vicinity of the aerator.

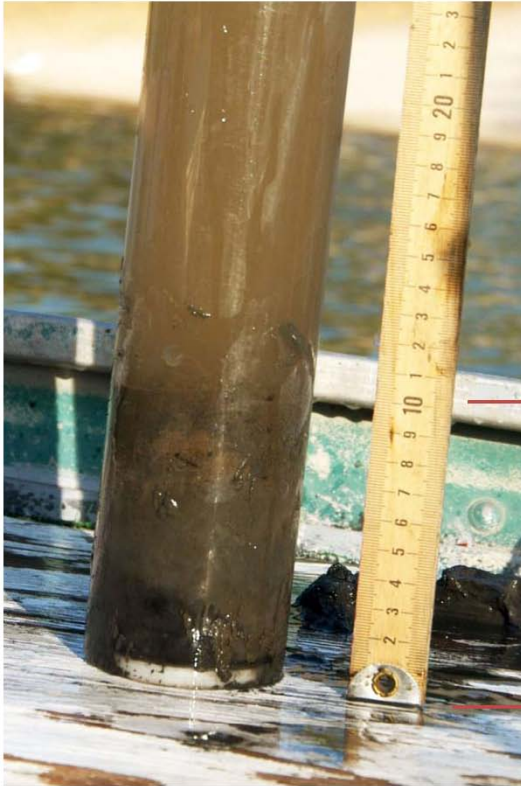
0 – 10 cm
Mostly organic with
Inorganic toward top

Figure 6. Photograph and description of Core 1.

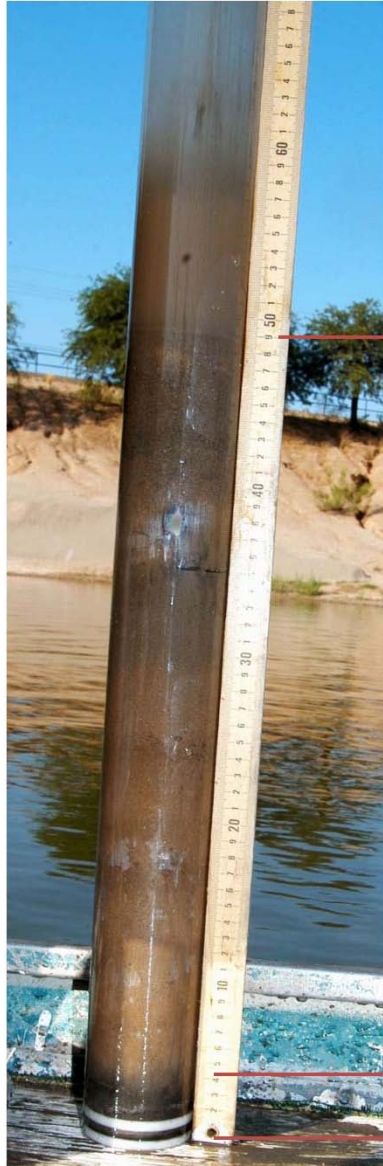
4 – 48.5 cm
Inorganic, sandy, with
some organic interbedding

0 – 4 cm Dense organic

Figure 9. Photograph and description of Core 4.

We collected cores to provide additional information on the sediment structure of the lake. Cores from the deeper regions of the lake did indeed show zones of high organic content, indicating a focusing of lower-density organic material in deeper regions. Cores 4 and 5, collected near the inflow at the south edge of the lake, and in a shallower part of the lake,

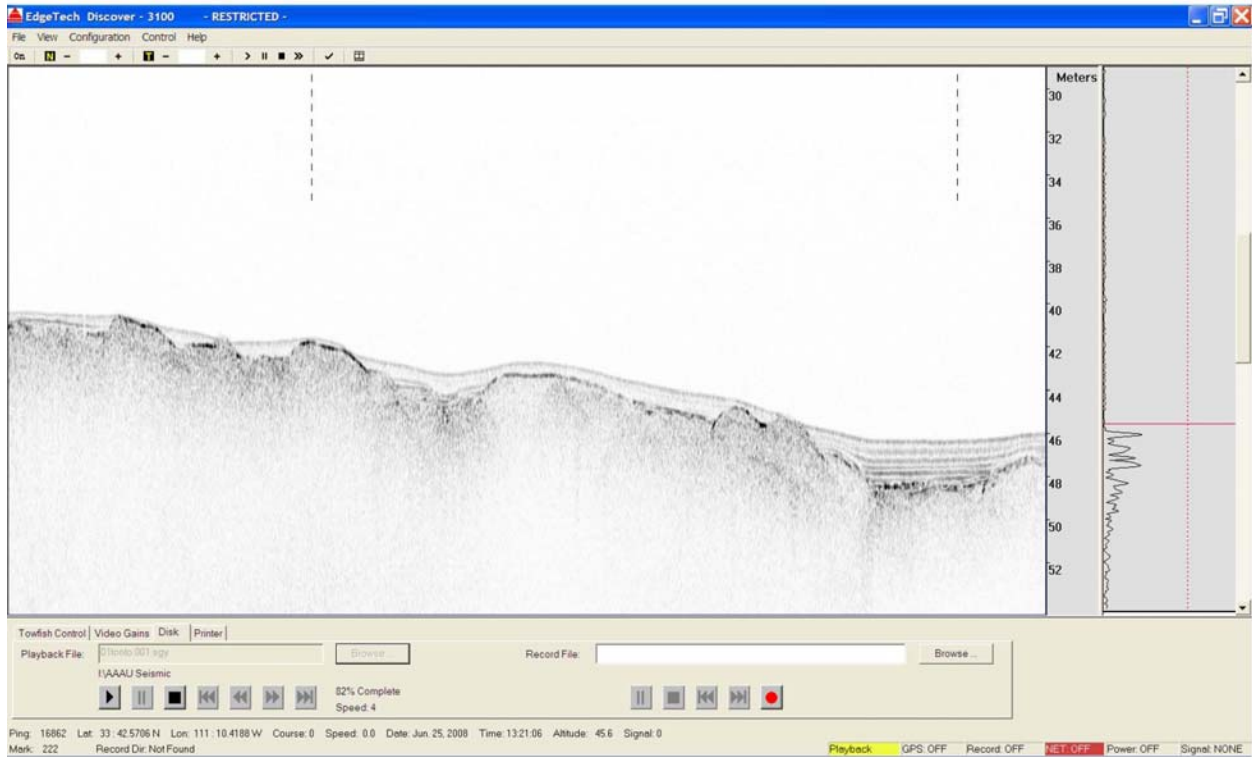
Figure 13. Seismic profile from the Tonto arm of Lake Roosevelt, Arizona.

The seismic system used for this study has excellent capability to profile silty or sandy sediments with low to moderate organic content and to distinguish interfaces between materials of differing density. Figure 13 shows an example from Lake Roosevelt, Arizona, using the identical equipment package that we used in Lakeside Lake. Sediment deposited after impoundment of the lake can be clearly seen draped over the native soil. To the right, layering can be distinguished as well. The layers represent contacts between sediment material of differing properties, such as density or organic content.
