## Electrical Conductivity and Major Cation Concentrations in Municipal Water from Tutuila Island, American Samoa

### Abstract

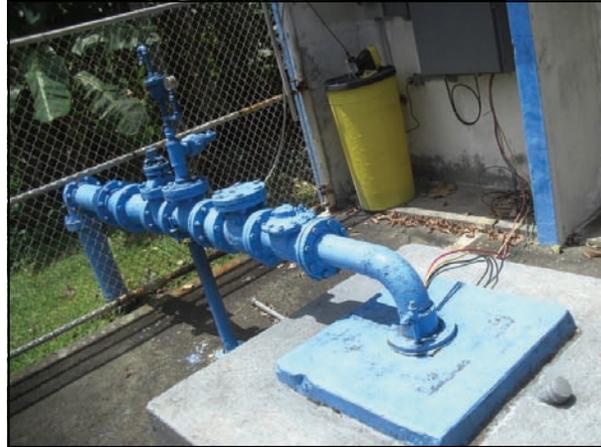
**Figure 1.** One of ASPA's 53 ground water wells. Wells are encased in concrete and may be as deep as 300 ft (90 m), requiring pumps of 30 to 40 hp (22 to 30 kW) to draw water to the surface. A 6% solution of sodium hypochlorite in the yellow drum is injected into the distribution system to disinfect the ground water as it reaches the surface.

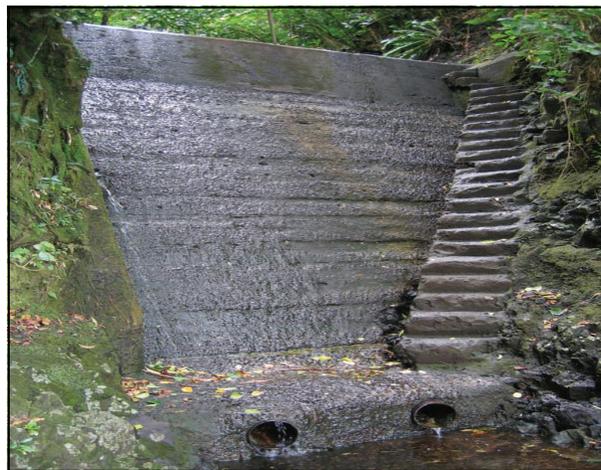
**Figure 2.** A reservoir built on a stream to supply villagers with water. These were typically built long before the municipal distribution system reached a village. Residents continue to rely upon them as a source of drinking water.

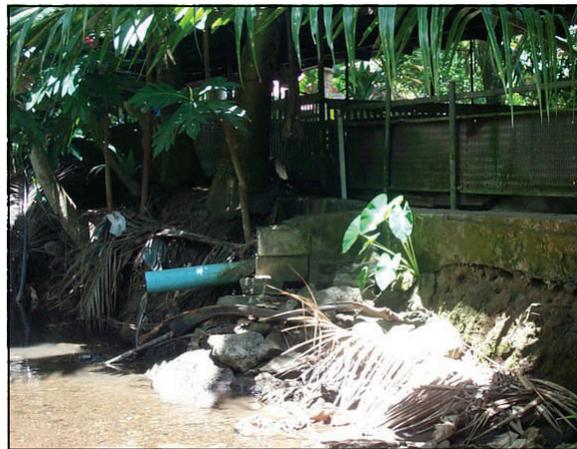
**Figure 3.** A non-compliant piggery discharging its waste directly into a stream. Prior to ASEPA's efforts to enforce the law disallowing such practices, the vast majority of piggeries were in violation. They lacked proper waste disposal systems. Most housed less than a dozen mature pigs. But some contained over a hundred pigs ranging in age and size from young piglets to breeding stock.

Widespread public outcry demanded enforcement of a law requiring piggeries to be set back at least 50 ft (15 m) from a stream or a building used for human habitation (*Samoa News*, 23 SEP 2005; Fig. 3). Despite initial opposition by some members of the Fono, ASEPA began an aggressive campaign in August and November 2006 to enforce the law. By the end of 2007, its efforts resulted in the closure of 69 non-compliant piggeries, and [with assistance from the USDA Natural Resource Conservation Service EQIP program] 57 others were able to bring their piggeries into compliance (*Samoa News*, 15 APR 2008).

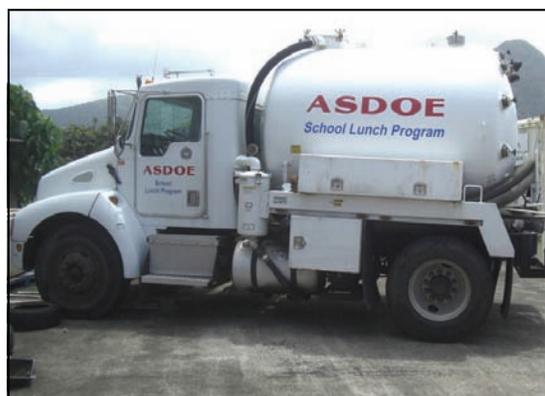
**Figure 4.** American Samoa Department of Education (ASDOE) School Lunch Program (SLP) water truck. With USDA approval, the ASDOE SLP delivers water, purified by a local bottled water vendor using reverse osmosis, to both public and private schools.

Throughout the 2010/2011 school year, ASPA provided coolers and 5-gallon (19 L) bottles for use by both private and public schools in order to ensure at least one 12-ounce (350 ml) serving of water per child per day (*Samoa News*, 04 AUG 2011). At the beginning of the 2011 school year, the American Samoa Department of Education had encouraging news that the USDA would allow the School Lunch Program of provide potable water to schools (*ibid.*; Fig. 4).

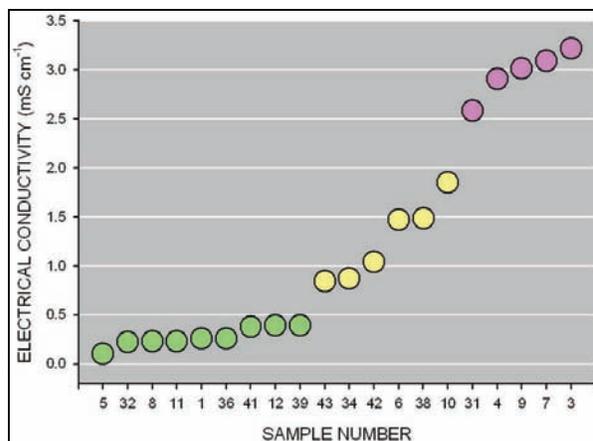
**Figure 5.** Electrical conductivity (EC) of 20 municipal water samples collected throughout Tutuila Island during 20 to 24 August, 2012. Sample numbers were arbitrarily assigned to collection bottles.

The 20 samples of tap water were divided into three classes based on their electrical conductivity (EC) levels (Fig. 5). EC is the ability of water to carry an electric current. This ability depends upon the number and type of ions dissolved in the water. EC is an indirect measure of the total dissolved solids (TDS) in water<sup>8</sup>. Therefore, TDS can easily be calculated using the formula in Fig. 6.

Samples with the lowest EC values had very little dissolved solids that could impart a taste. These were color-coded green. Samples with the highest EC values were highest in TDS. They were color-coded red. And samples whose EC values fell between these two extremes were color-coded yellow. EC and other parameters tested are given in Table 1.

A comparison of EC levels (Fig. 5) with the amount of calcium and magnesium, expressed as calcium carbonate equivalent, or  $\text{CaCO}_3$ , and sodium reveals that the samples with lowest EC values had little of these cations dissolved in them (Fig. 7). For samples with medium and high EC values, the relationship between EC and cation concentration is more complex.

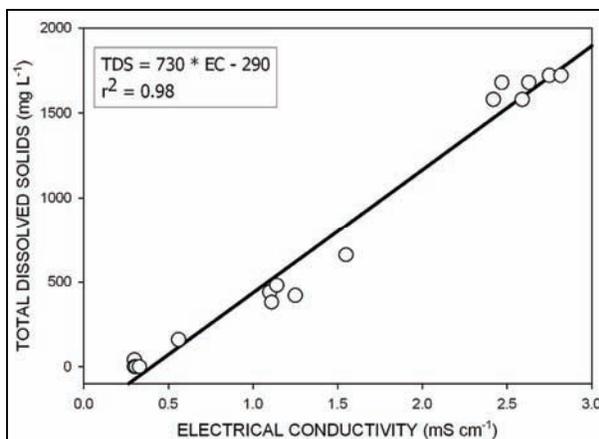
**Figure 6.** A plot of Total Dissolved Solids (TDS) with Electrical Conductivity (EC) shows their linear relationship.

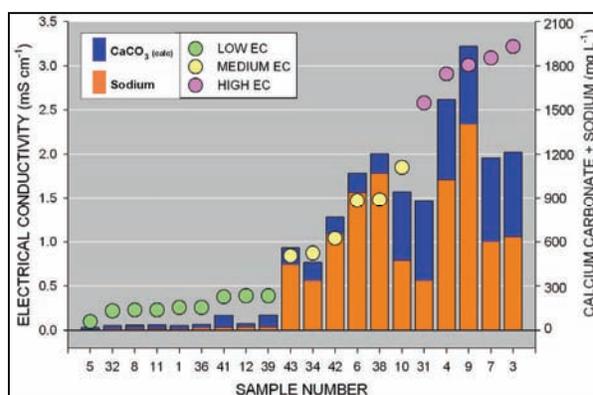
**Figure 7.** Comparison of EC values to the amount of calcium and magnesium, expressed as calcium carbonate equivalents, and sodium.

Samples 6 and 38, for instance, with medium EC values, have about the same level of dissolved cations as samples 7 and 3, with high EC values. They differ, though, in that the two medium EC samples have significantly more sodium cations relative to calcium carbonate equivalent, whereas the two high EC samples have about equal amounts of sodium and calcium carbonate equivalent. This near equal ratio of sodium to calcium carbonate equivalent holds for all six high EC samples. And the predominance of sodium to calcium carbonate equivalent holds for all medium EC

samples except for sample number 10. This sample shows a nearly identical sodium to calcium carbonate equivalent ratio as sample number 31, yet the latter sample's EC is significantly greater.

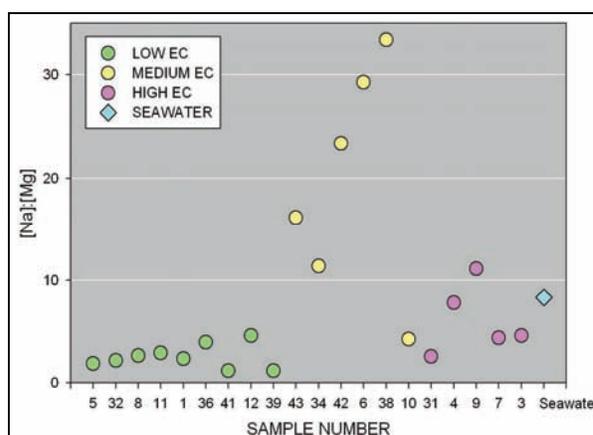
**Figure 8.** Ratios of sodium to magnesium for the 20 tap water samples. This ratio, i.e., 9:1, is also shown for seawater.

sulfate anions. Calcium and magnesium salts of these anions are soluble. At the pH of ground water, i.e., slightly acidic owing to dissolved carbon dioxide, bicarbonate is the overwhelmingly dominant equilibrium species for aqueous solutions of carbon dioxide. Therefore, the unusually high Na:Mg ratios for the tap water samples of medium EC values must be due to an exogenous source. We speculate that this source is sodium hypochlorite used to disinfect the wells by shock chlorination.

A second anomaly seen in Fig. 8 is the lower-than-seawater ratios of Na:Mg for all tap water samples with low EC values and for 4 of the 5 high EC value samples. If the ratios of Na:Mg for samples with low EC values can be attributed to natural dissolution of soil and rock, then a much greater amount of this same dissolution might be occurring in wells supplying villages along Tutuila Island's south-eastern shore (Fig. 9). Alternatively, seawater intrusion might be taking place in these wells, but a corresponding amount of magnesium must be added to account for a Na:Mg ratio less than that of seawater. A possible source of this magnesium may be olivine,  $(Mg,Fe)_2SO_4$ , an easily weathered mineral found in basalts such as those forming the Samoan archipelago. Without further evidence, though, this suggested accounting for the lower-than-seawater ratios of Na:Mg in these tap water samples must remain as speculation.

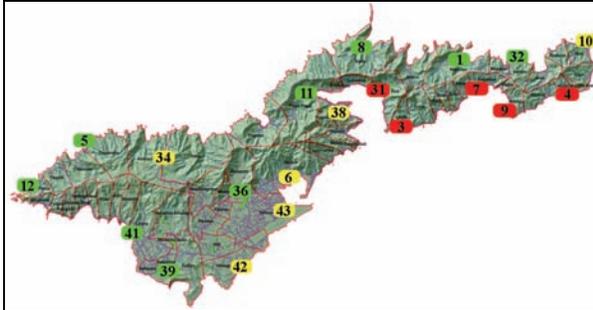
**Figure 9.** Location of tap water samples taken 20 to 24 AUG 2012 on Tutuila Island, American Samoa. Numbers and colors correspond to the sample numbers and color-codes used elsewhere in this report but the colors are intensified for clarity.

Samples with low EC values were predominantly from Western Tutuila and the north shore of Eastern Tutuila. Samples from three villages bordering Pago Harbor—Fagatogo (38), Pago Pago (11), and Aua (31)—show that their tap waters run the spectrum from low to high EC values. The EC results for tap water sampled in August 2012 were consistent with results obtained from samples collected in April 2012, with two exceptions: In April, Aoloau (34) had a low EC value while Tula (10) had a high EC value. Cation concentrations were not determined on samples collected in April.
